# *David A. Andersen & Associates*

## Infrared Thermal Inspection Report

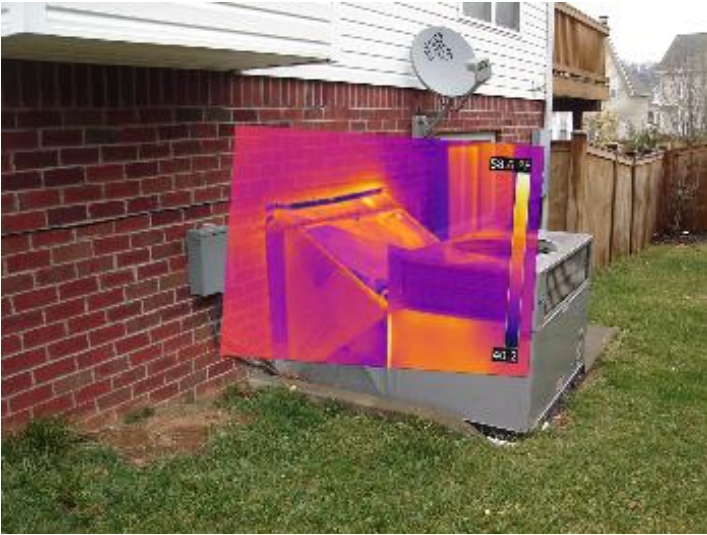
There is an apparent leaking air duct at the outdoor HVAC system. This will produce a considerable efficiency loss.

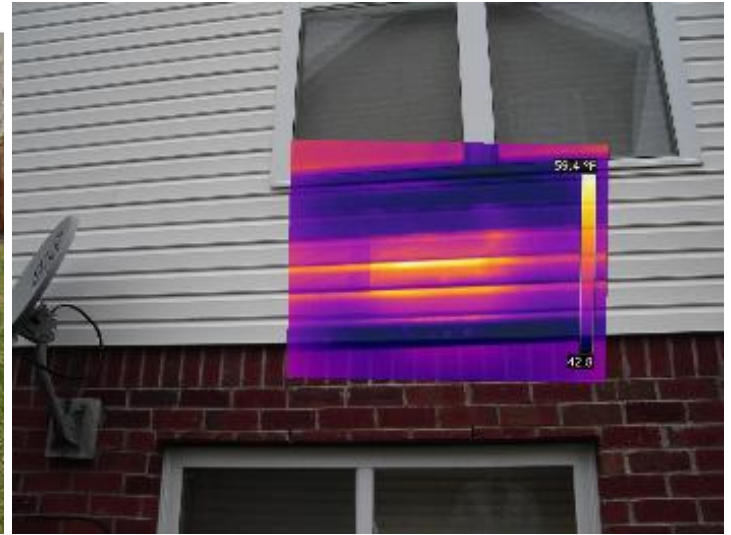
Indication of a leaking air duct from the interior of the house. Air is leaking between the basement ceiling and first floor.

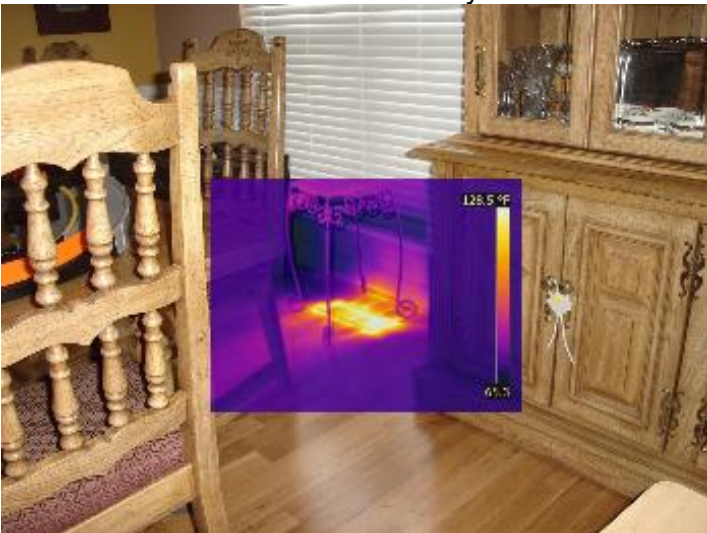
Indication of air loss at the supply air boot below the register.

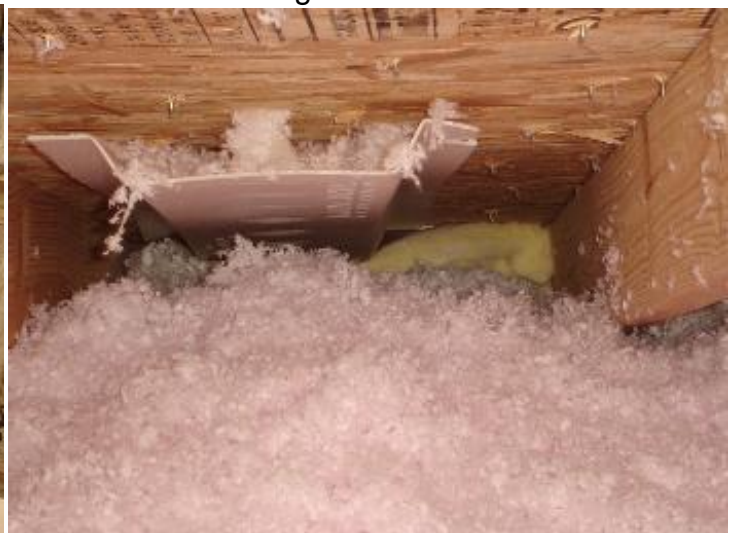
There is still indication of heat loss at the junction of the ceiling and wall in the left rear second-floor bedroom. Air leakage past the installed insulation and insufficient insulation at the eve is likely creating this heat loss.

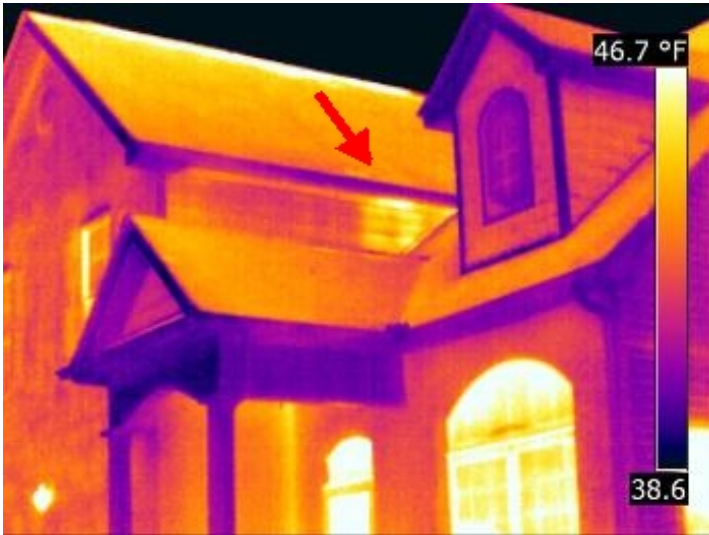
Inadequate insulation in the master bedroom is evident on the exterior wall of the house.

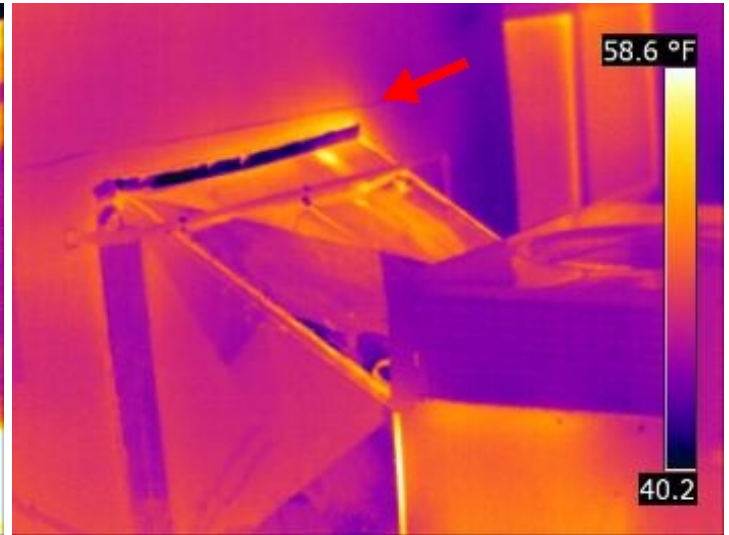
Indication of the HVAC air duct leakage.

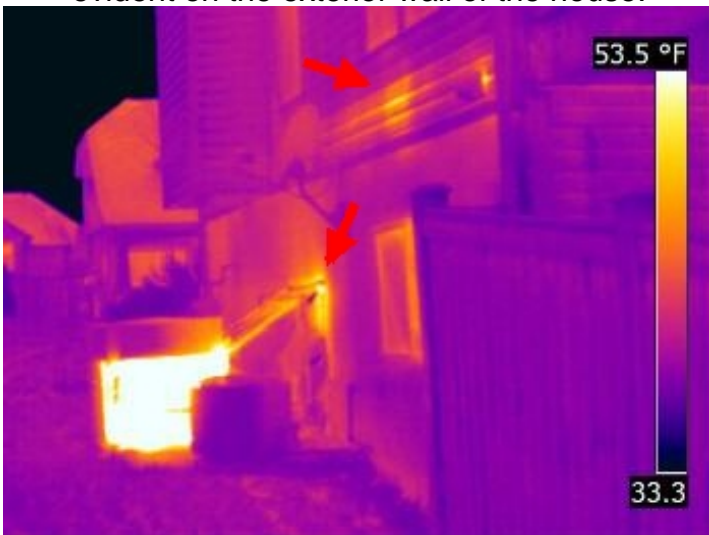
Indication of air duct leakage at the unit and through the first floor wall. Note that there is air leakage along the entire rim joists just above the foundation.

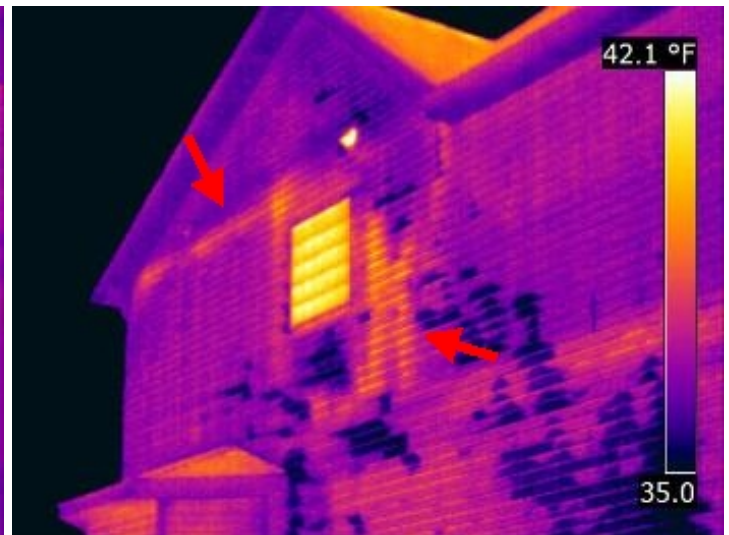
Indication of air leakage at the ceiling/wall of the second-floor left rear bedroom. Also air leakage is evident adjacent to the window from floor to ceiling.

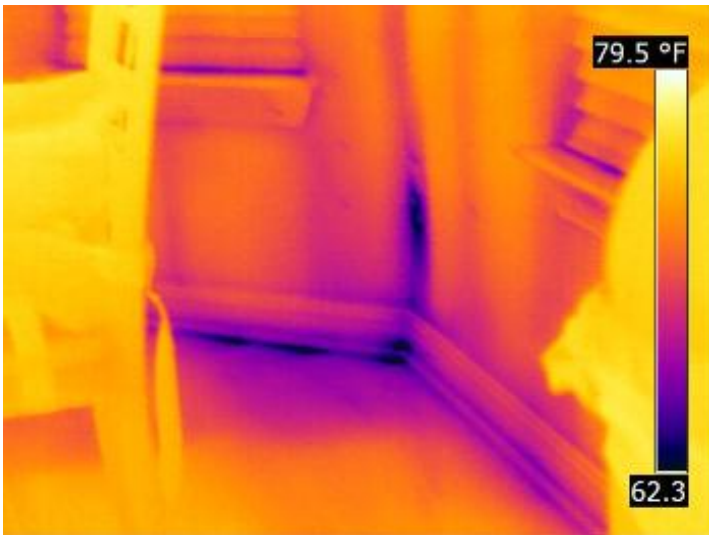
Air infiltration in the kitchen dining area at the electrical outlet and below the baseboard from a leaking wall framing plate.

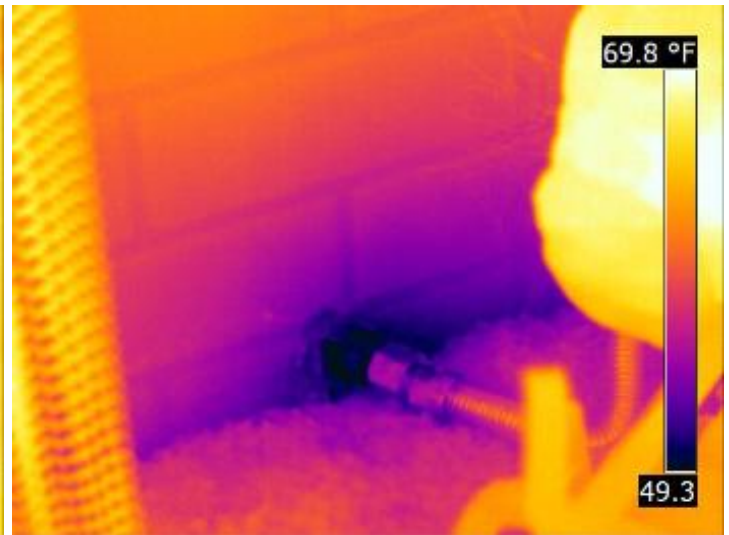
Indication of air leakage into the wood fabricated chimney/fireplace appliance. Interior infiltration has been sealed but external infiltration of the wall system is still occurring and there is likely insufficient insulation installed.

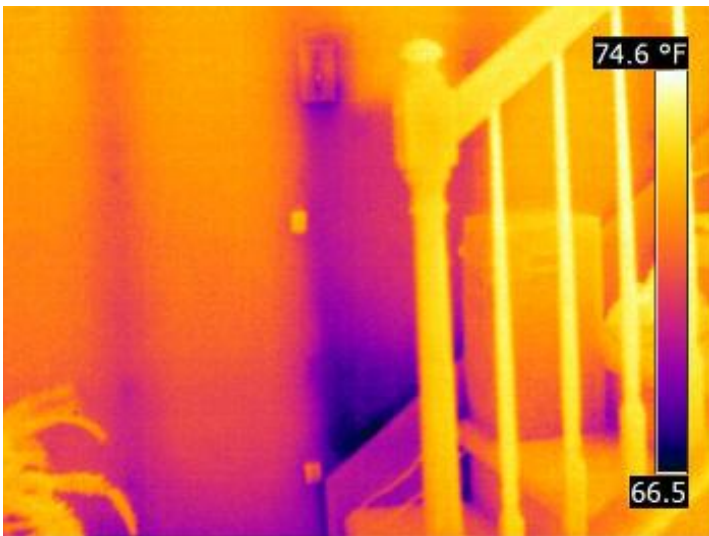
Air infiltration through the switch box from air infiltrating through the electrical service panel in the garage.

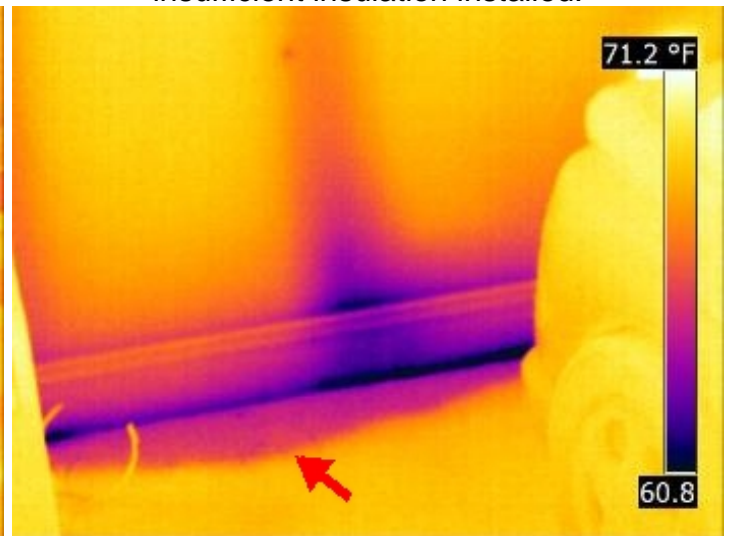
Air infiltration at the baseboard at the rear wall of the second-floor rear bedroom. Note the cool carpet against the baseboard where air is passing through the carpet.

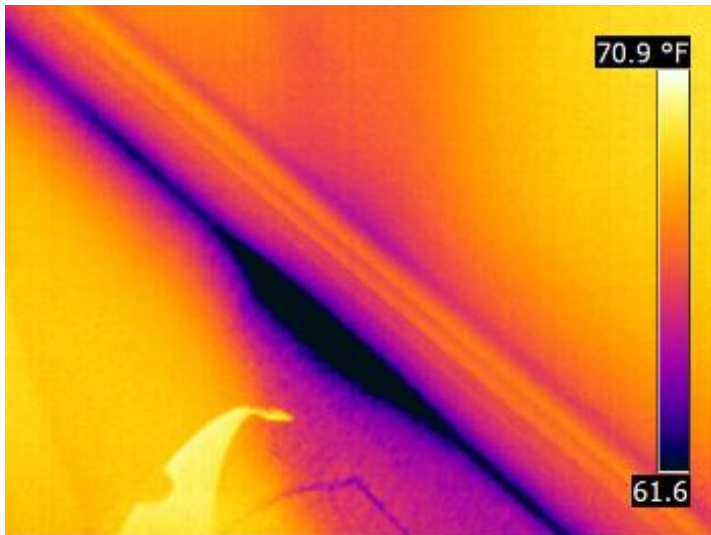
Air infiltration at the baseboard second-floor rear bedroom.

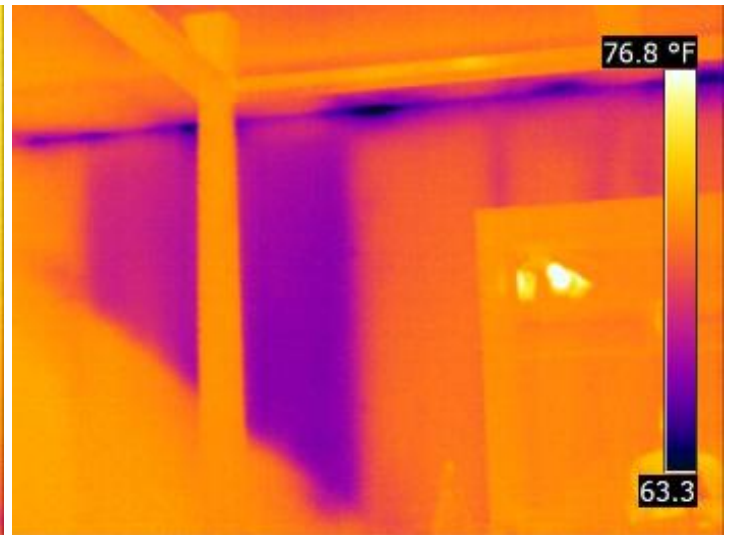
Inadequate insulation in the master bedroom viewed from the interior. Exterior heat lost is detected on the exterior wall.

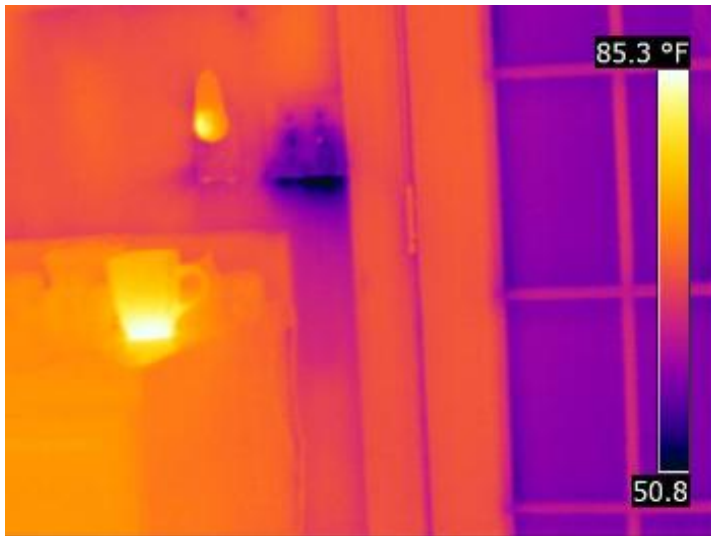
Air infiltration through the light switch at the rear kitchen entry door.

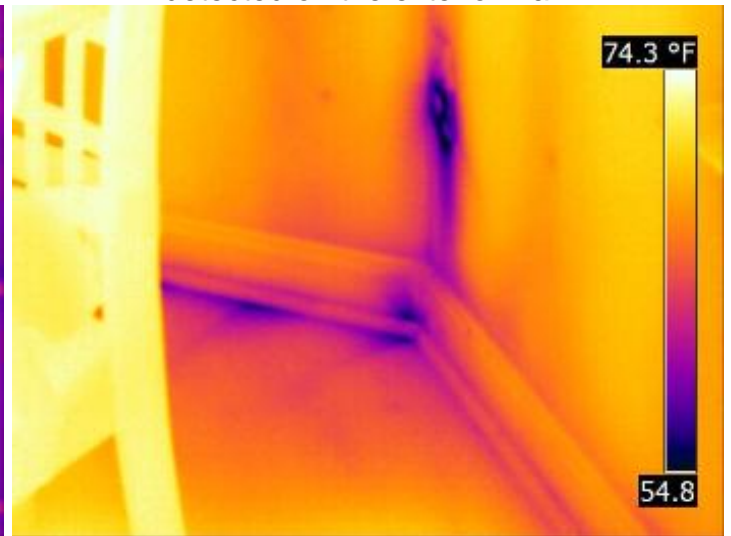
Air infiltration at a wall outlet in the kitchen dining area. Also air leakage from below the baseboard.

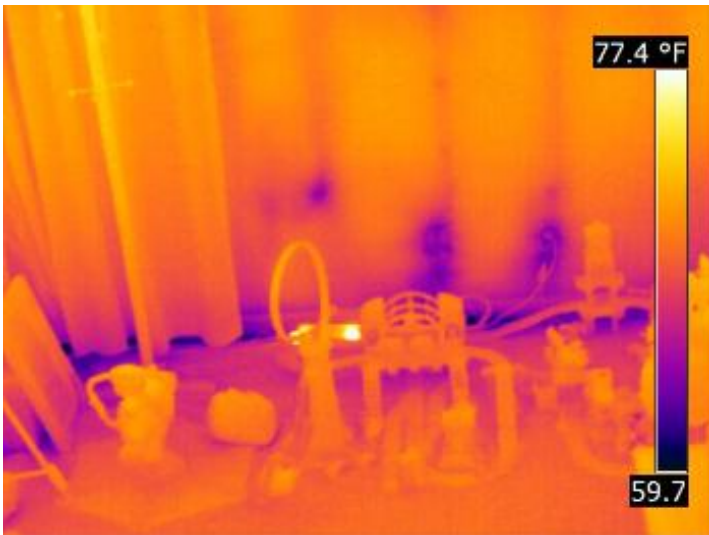
Air infiltration at wall outlets and baseboard in the basement viewed from the basement stairs.

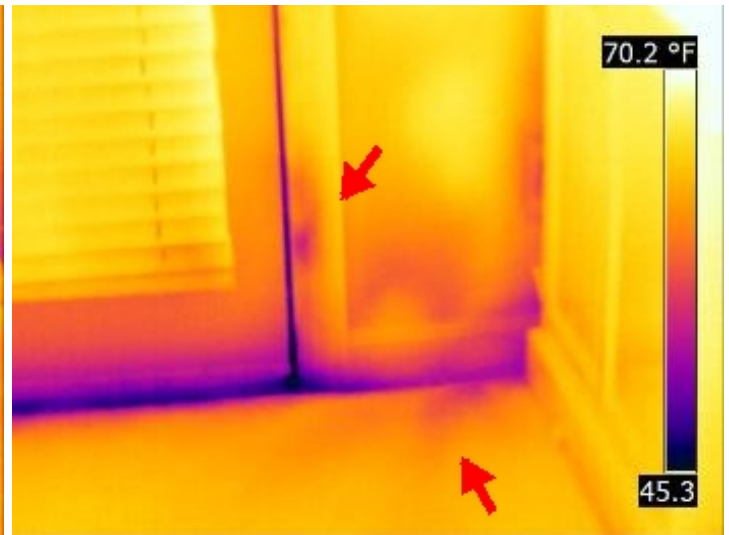
Air infiltration at the basement entry door as well as areas behind the office desk which is indicating considerable air infiltration from behind the desk.

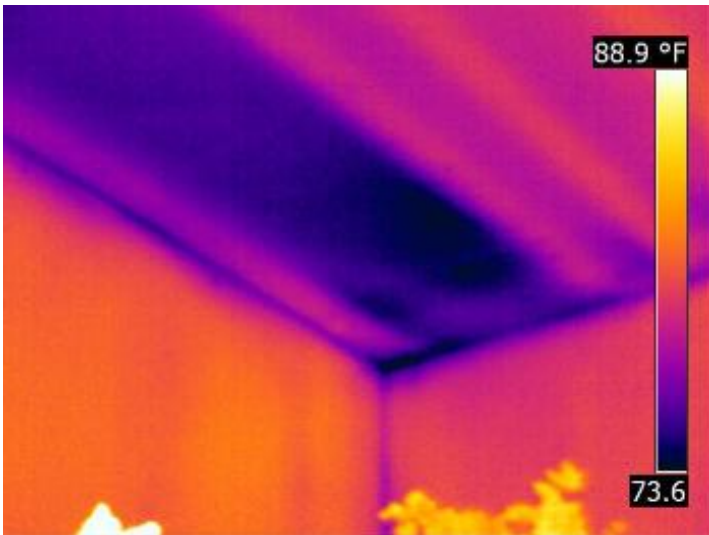
Apparent air infiltration from below the kitchen eating area cantilevered floor/wall. This condition extends into the room as far as the closet door.

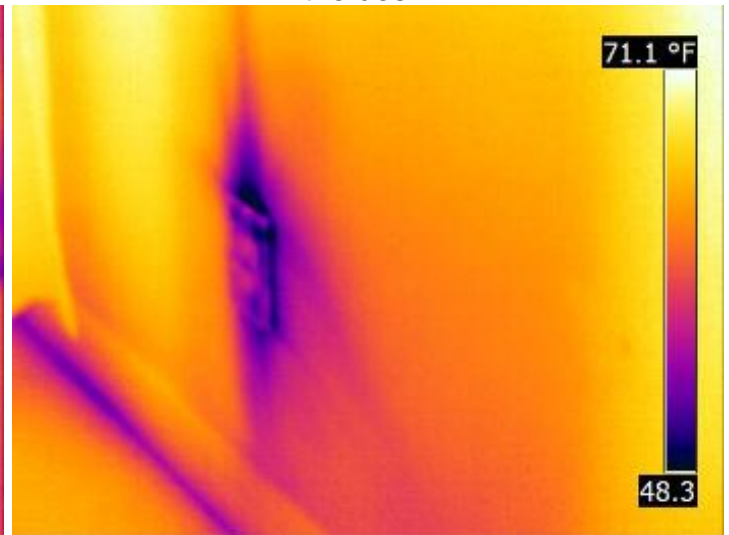
Air infiltration at the wall outlet in the basement rear bedroom.

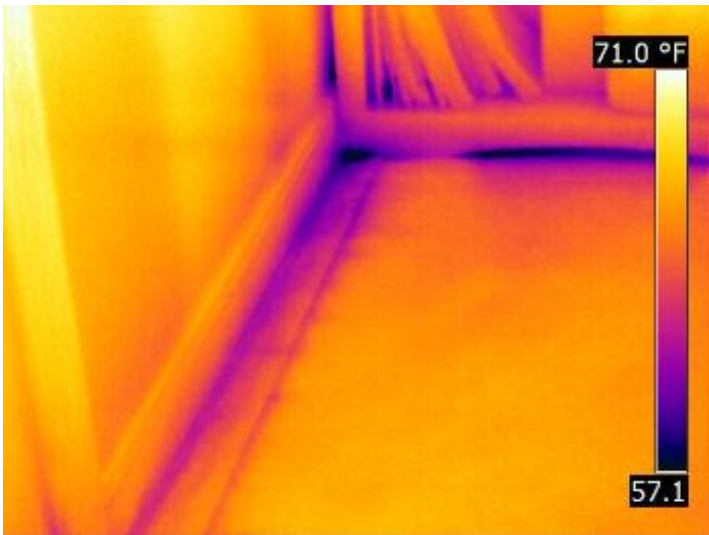
Air infiltration at the floor in the basement rear bedroom.

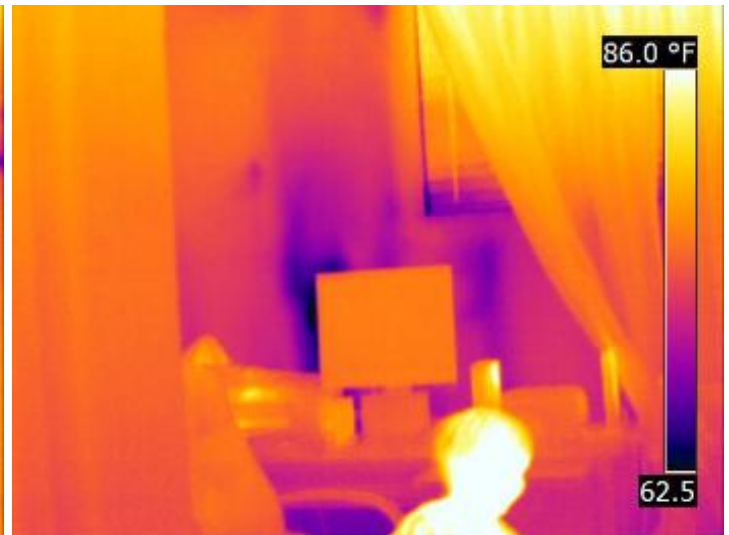
Air infiltration through the wall behind the office desk/computer screen.

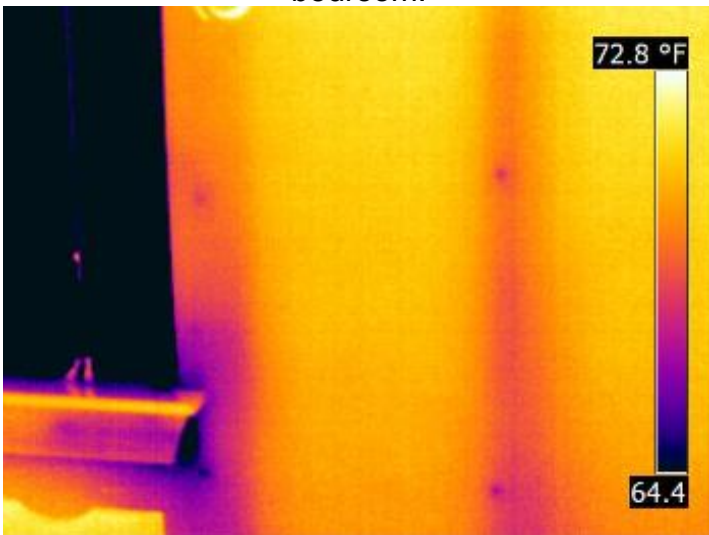
Air infiltration at the windowsill in the basement bedroom.

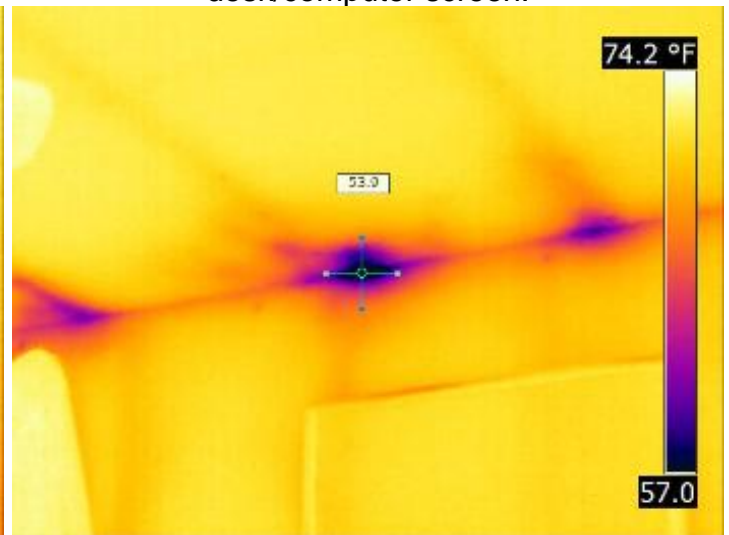
Considerable low-temperature in the second-floor rear bedroom from inadequate insulation at the eave.
