Infrared Inspection Report

DATE OF INSPECTION: 21 Feb 2009
 TIME: 1120am

Subject: Murphy; Equine Scan

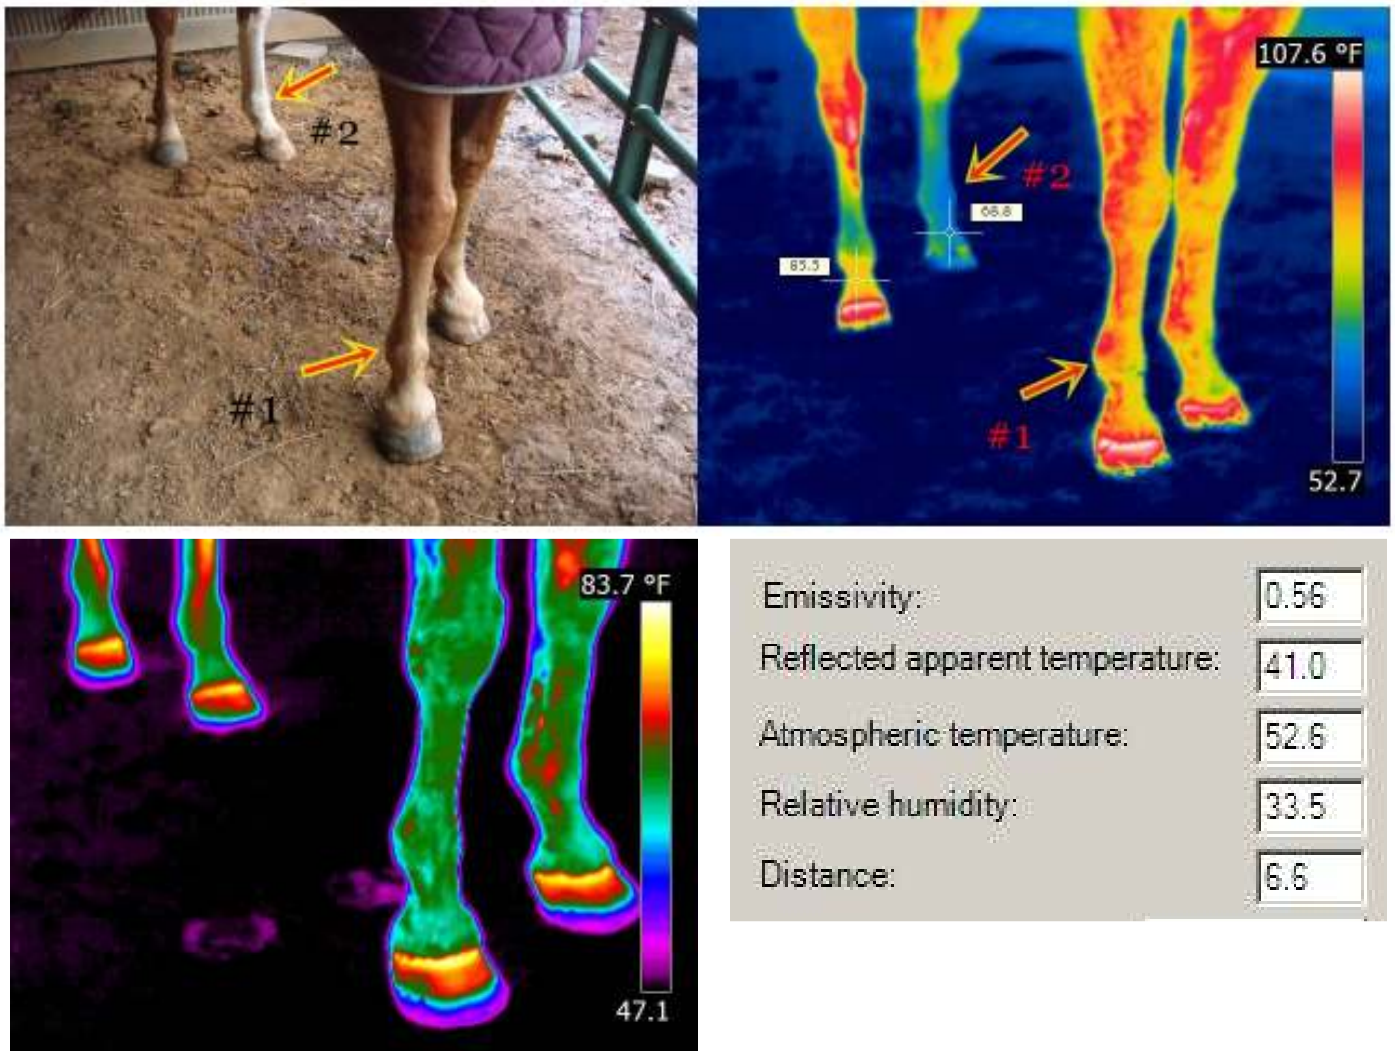
Location: View of all four legs from the right front quarter.

IR thermology revealed: that in addition to minor stone bruising of the right front hoof, a more substantial injury was present on the left rear leg below the knee. Elevated temperature in the right rear leg was also evident which may be associated with compensation of the injured left rear leg.

#1 The horse was visibly favoring the right front leg at the fetlock joint. Though there was obvious lameness, there was no indication of significant increased temperature at the fetlock joint which would be an indication of inflammation.

#2 There was a decrease in temperature noted in the left rear leg below the knee. A temperature differential of 16.6°F was noted below the fetlock joint of both rear legs. Occasionally a skin wound will injure underlying arteries and cause decreased blood flow to the area below the injury. Changes such as tingling, burning, numbness, or moderate to severe pain may indicate an injured artery that supplies the blood flow to the leg.

The bottom left scan is a baseline thermograph of the horse after a previous veterinary check indicating no pre-existing condition.

The horse is in significant pain on the right front and left rear legs. The horse was free-roaming at pasture at the time of inspection. It is recommended that the horse be stalled pending veterinary evaluation.

The horse should be put up and immobilized until further veterinary care can be provided.

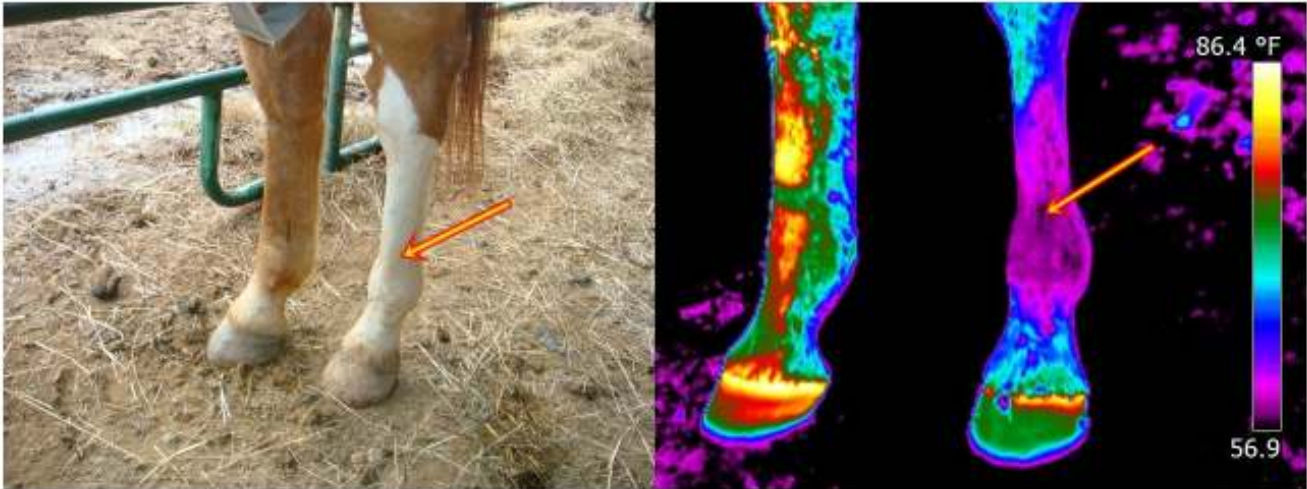
Location: Left rear leg view quartering forward.

A scan comparing both hind legs indicated a temperature differential of 30.9°F. The maximum temperature of the right hind leg was 113.7°F which is above the 100.5°F average rectal temperature of a horse.

Palpation of the left leg indicated extreme sensitivity at the indicated area.

Image Description
Hind leg comparison: viewed quartering forward.

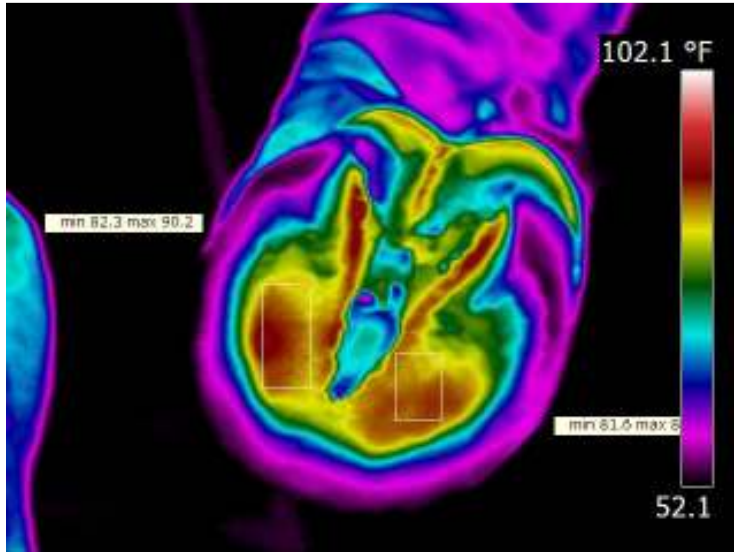
Location: Right front hoof viewed from the rear.

Comments: The horse was pointing the right front leg at rest and shows significant reluctance to load bodyweight on this digit when walking.

Thermal scans of the hoof wall and sole did not indicate significant increase in temperature in comparison with the left front hoof.

Image Description
Right Front Hoof Sole
