# Infrared Inspection Report

DATE OF INSPECTION:    21 Feb 2009  
 TIME: 1120am

Subject: Murphy; Equine Scan

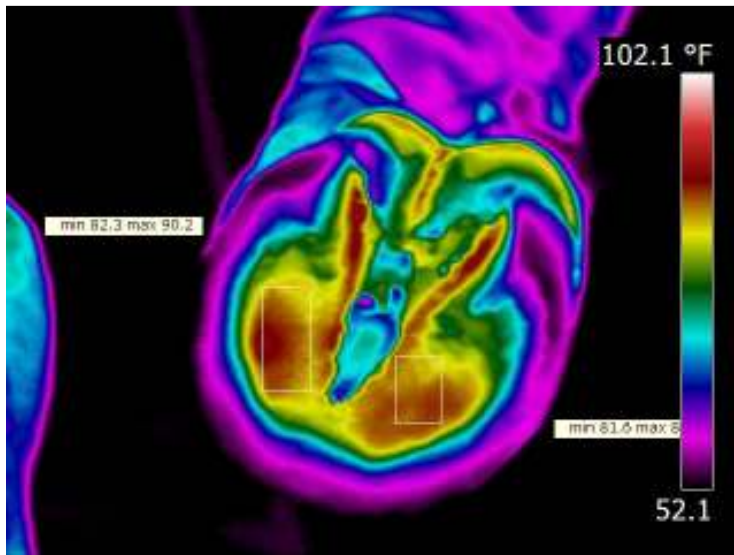
**IR\_0448.jpg**  
Size: 110 KB  
Created: 2009:02:21 11:03:39  
Camera: ThemaCAM BX320  
Lens: FOV 25

**Comments:** The horse was pointing the right front leg at rest and shows significant reluctance to load bodyweight on this digit when walking.

Thermal scans of the hoof wall and sole did not indicate significant increase in temperature in comparison with the left front hoof.

**Image Description**  
Right Front Hoof Sole
