Infrared Inspection Report

DATE OF INSPECTION: 21 Feb 2009
 TIME: 1120am

Subject: Murphy; Equine Scan

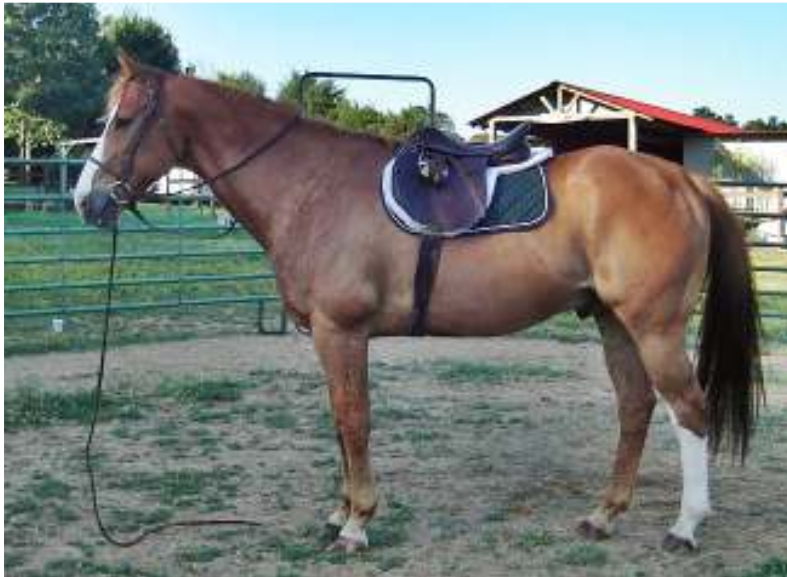
Location: View of all four legs from the right front quarter.

#1 The horse was visibly favoring the right front leg at the fetlock joint. Though there was obvious lameness, there was no indication of significant increased temperature at the fetlock joint which would be an indication of inflammation.

#2 There was a decrease in temperature noted in the left rear leg below the knee. A temperature differential of 16.6°F was noted below the fetlock joint of both rear legs. Occasionally a skin wound will injure underlying arteries and cause decreased blood flow to the area below the injury. Changes such as tingling, burning, numbness, or moderate to severe pain may indicate an injured artery that supplies the blood flow to the leg.

The bottom left scan is a baseline thermograph of the horse after a previous veterinary check indicating no pre-existing condition.
